14.4.8 Sample Collection Bag Fell Off the Portable Life Support System Tool Carrier

14.4.9 Lunar Surface Far Ultraviolet Camera Azimuth Adjustment Became More Difficult

14.4.10 Velcro Patch Came Off Both Padded Sample Bags

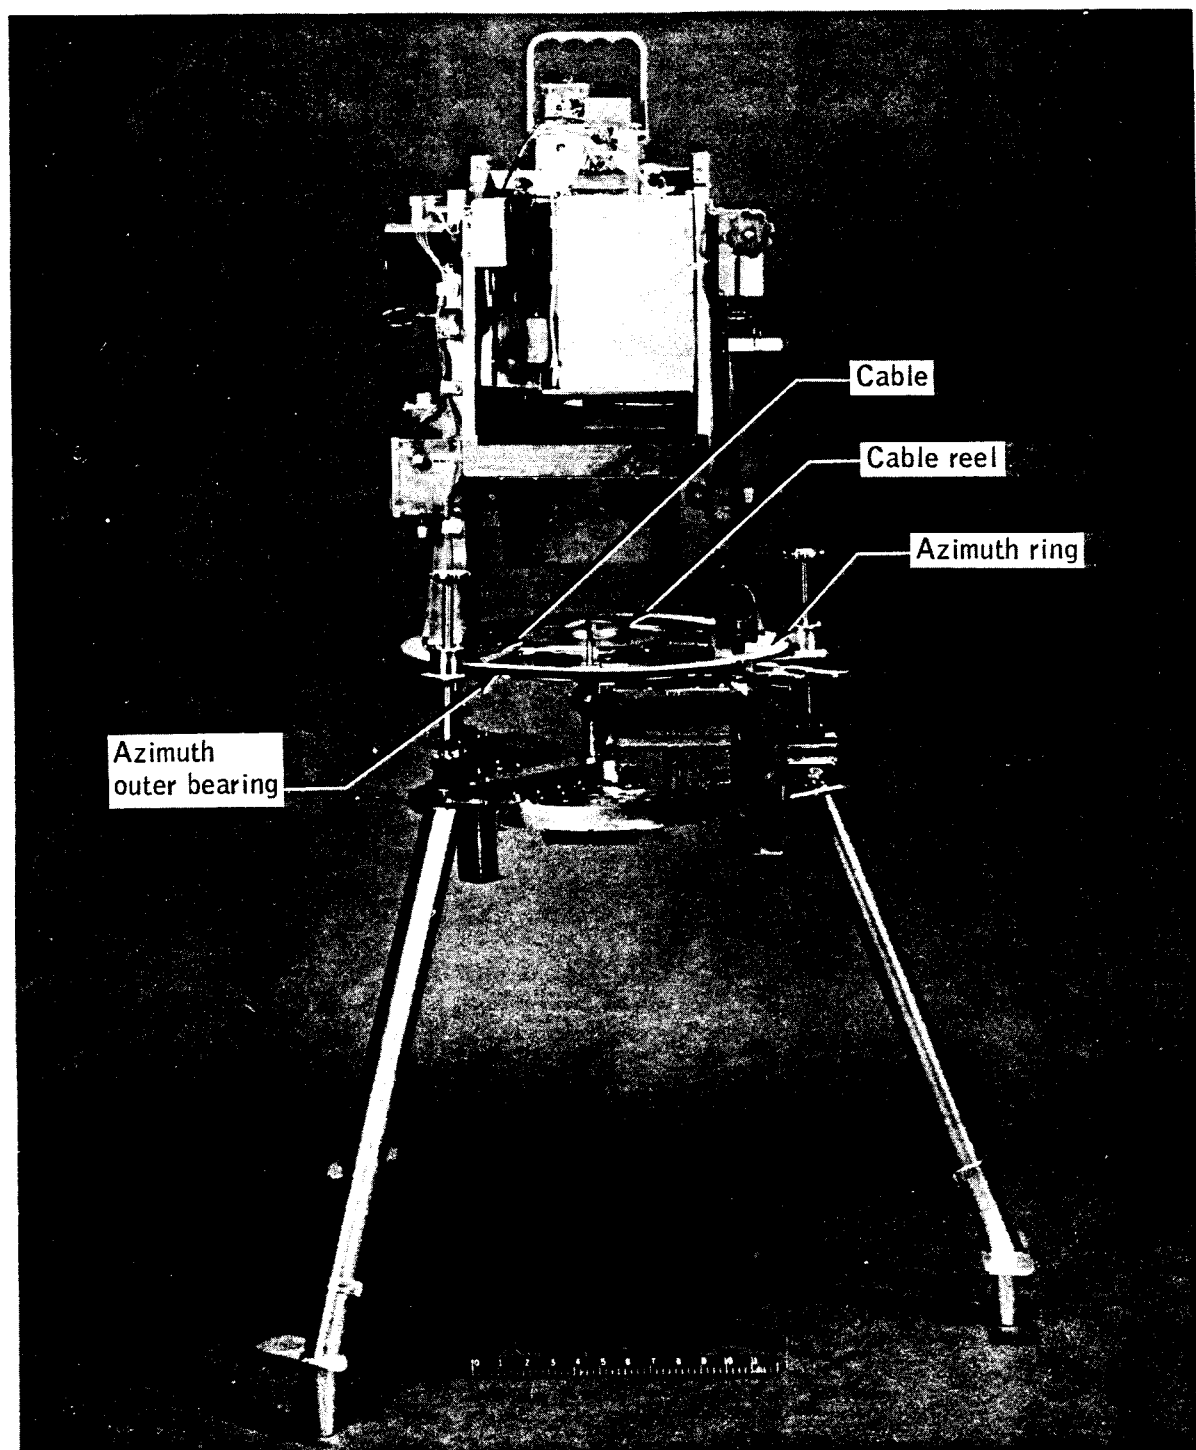
Rotating the camera assembly for each azimuth setting was more difficult than expected, and became progressively difficult during the lunar stay.

To adjust the azimuth to the proper dial reading, the camera is rotated on a 12.5-inch diameter ball-bearing ring (fig. 14-63). The bearing is not sealed; however, the crew did not observe any lunar dust on the bearing.

The azimuth ring bearing was packed with a waxy, low-outgassing grease which stiffens appreciably at temperature below 50° F. This grease is normally used as a sealant rather than a lubricant. The camera was intentionally kept in the shade to protect the film from high temperatures. As a result, the grease stiffened. The manual azimuth adjustment operation was not included in cold chamber tests with other operations of the camera.

Figure 14-63.- Far ultraviolet camera.

The difficulty was caused by the use of the wrong type of grease in the azimuth ring bearing.

The experiment is not scheduled for another flight, and no further action is required.

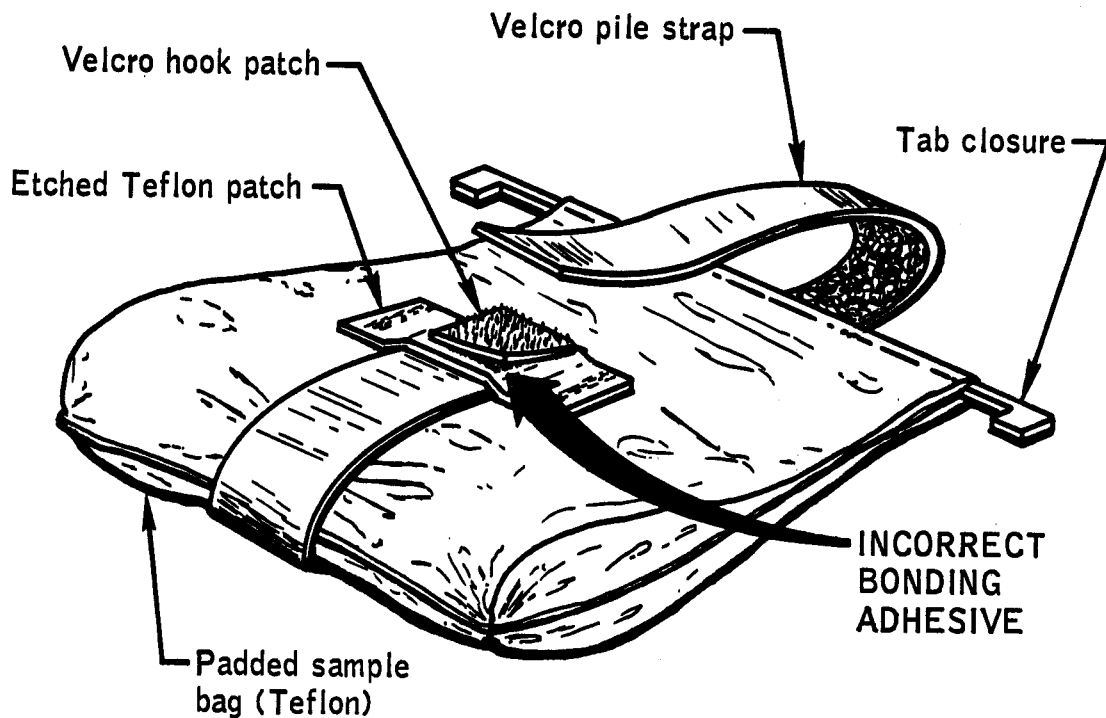
When the crew wrapped the Velcro strap around each of the padded sample bags to further secure them, the Velcro attachment patches came off the bags and the straps were ineffective.

A 20-inch-long wrap-around Velcro pile strap is provided to hold the bag closed in addition to the usual tab closure (fig. 14-64). One end of the strap is bonded with a fluorel adhesive to an etched Teflon patch which

Figure 14-64.- Padded sample bag.
