15.4.3 Lunar Ejecta And Meteorite Experiment Temperature High

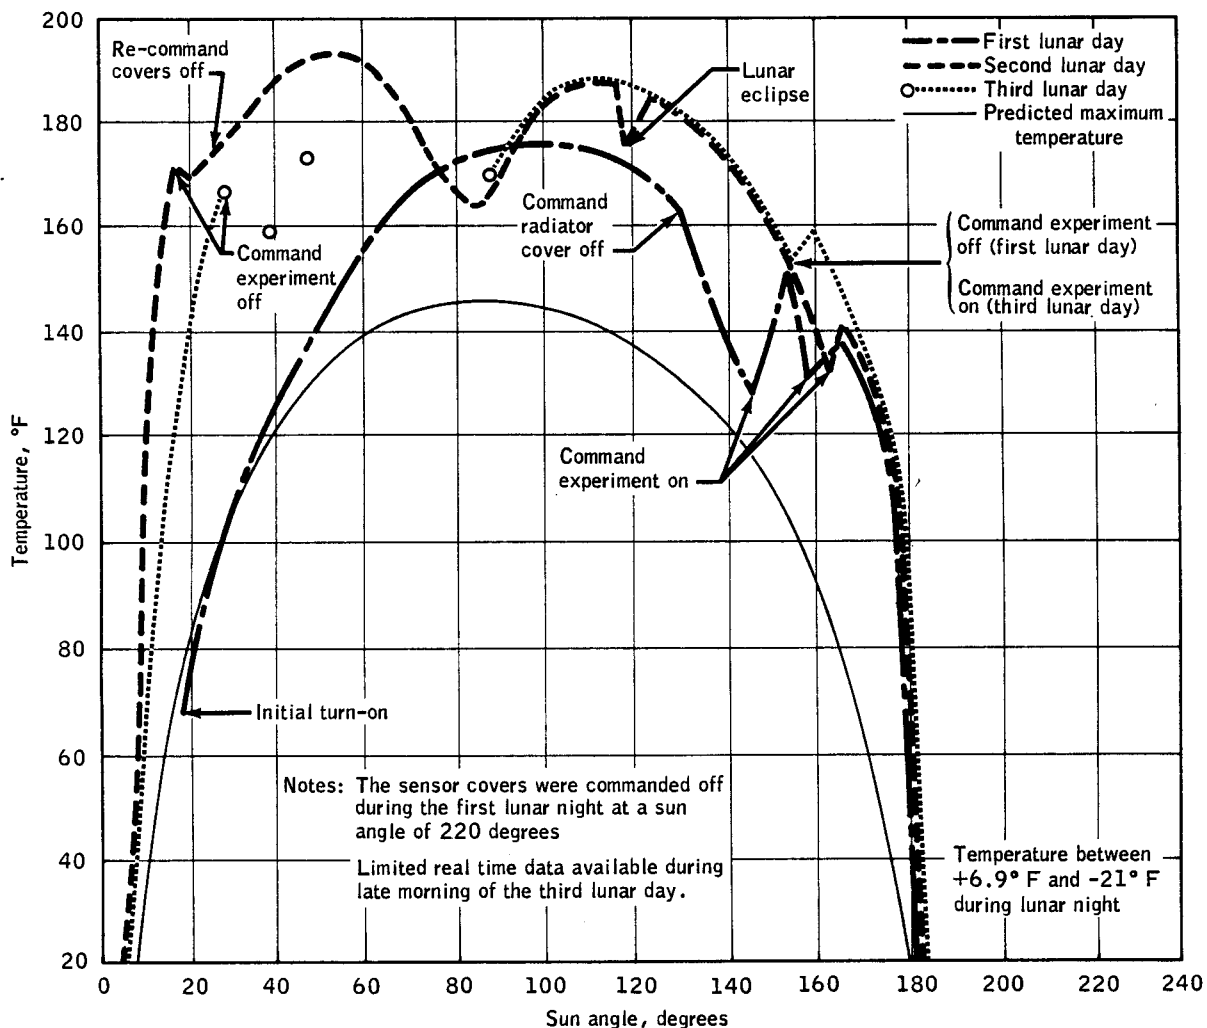
The temperature of the lunar ejecta and meteorite experiment was higher than predicted during the first and second lunar days (fig. 15-21). The high temperatures occurred with all combinations of experiment modes: on, off, and standby, with all dust covers on, with only the sensor covers on, and with all covers off. Whenever the experiment was in the "operate-on" mode, the science data indicated normal operation of the experiment. The maximum allowable temperature for survival of the electronic components has not been exceeded, however, it was necessary to command the experiment from "operate-on" to "off" at a sun angle of about 153 degrees during the first lunar day and at a sun angle of about 16 degrees during the second lunar day. Following sunrise of the second lunar day, the temperature rose from 0° F at 0° sun angle to about 168° F at 15° sun angle (fig. 15-21). The instrument was commanded to standby and then to off because the temperature continued to rise. In the off mode, with no power to the instrument, the temperature rise rate was lower.

The experiment temperature was cooler during the morning of the third lunar day as compared to the second. This could be attributed to the procedural change which turned the experiment off for 1 1/2 hours through sunrise and sunset. Data from the suprathreshold ion detector and charged particle lunar environment experiments, deployed on previous Apollo missions, indicate that a flux of -100 to -750 volts can occur near the optical terminator (before optical sunrise and after optical sunset). During the lunar day, the surface is stable with photo electron layering at

Figure 15-21.- Lunar ejecta and meteorites experiment temperature data.

+10 to +20 volts. It is postulated that when the experiment is on (sensor film at -3 volts and suppressor grid at -7 volts), the charge differential observed at these times may result in an accretion of lunar dust on the east and west sensors. Based on this, the experiment was turned off each sunset and sunrise after the second lunar day. The presence of dust on the sensor film and grid would degrade the thermal control system and result in higher experiment temperatures during the lunar day.

The current thermal profile permits experiment operation for 100-percent of the nighttime and 30 percent during the lunar day. If the thermal profile does not improve, consideration will be given to thermal testing on the qualification unit to ascertain whether or not the temperature limits can be raised to permit additional daytime operation. Preliminary

Since the experiment is not scheduled for future missions, no corrective actions will be taken.
